# Manhole Inspection Summary

Manhole # S67O\_\_004MH

Insp Date: **2/7/08 11:20 AM**

**Location** Address: **6700 Boston St.**

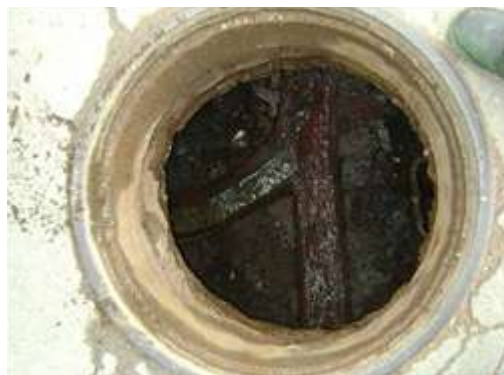
Top View

Condition: ☐ Sound ☐ Cracked ☐ Root Intrusion ☒ **Loose Brick** ☒ **Deteriorated**

Infiltration: ☐ None ☒ **Joint** ☒ **Cracks** ☒ **Mortar** ☐ Roots ☐ Wall

Count: **1** Missing: **0** ☒ **Corroded**

☒ **Evidence Of Surcharge** Depth: **2** (ft.) ☐ Active Surcharge Present

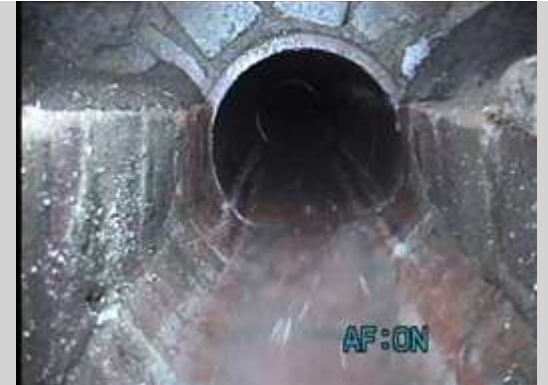
12 O'Clock Outflow

8 in. Circular Gravity Sewer  
Pipe Out @ 12 O'Clock

Pipe Height: **8.4** (in.) Rod and Bar (Angled)  
Pipe Material: **Clay** ☐ Pipe Lined  
Invert Depth: **4.58** (ft.) Flow Characteristics: **Fast**  
Deposits: ☒ None ☐ **Mud** ☐ Sludge ☐ Debris ☐ Grease  
Silt Depth: (in.) Deposits Extent:  
Infiltration: **None** Pipe Seal Cond: **Sound**

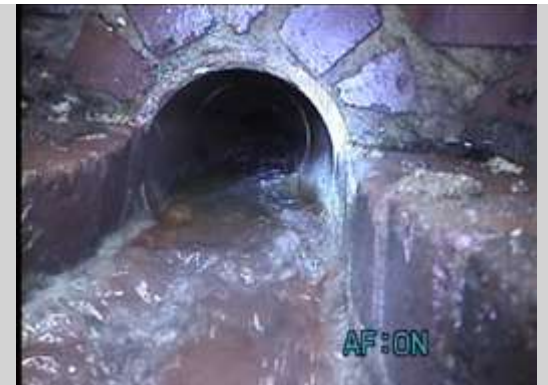
6 O'Clock Inflow

8 in. Circular Gravity Sewer  
Pipe In @ 6 O'Clock

Pipe Height: **8.4** (in.) Rod and Bar (Angled)  
Pipe Material: **Clay** ☐ Pipe Lined  
Invert Depth: **4.54** (ft.) Flow Characteristics: **Fast**  
Deposits: ☒ None ☐ **Mud** ☐ Sludge ☐ Debris ☐ Grease  
Silt Depth: (in.) Deposits Extent:  
Infiltration: **None** Pipe Seal Cond: **Sound**

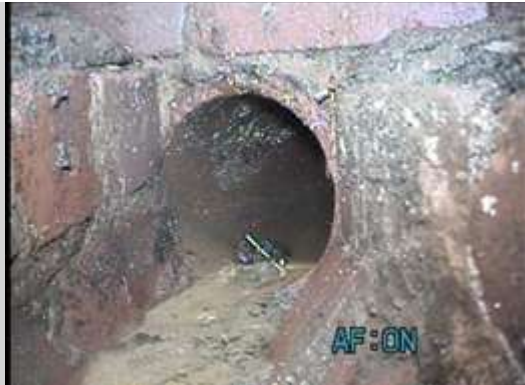
9 O'Clock Inflow

6 in. Circular Gravity Sewer

Pipe In @ 9 O'Clock

Deposits: ☐ None ☒ **Mud** ☐ Sludge ☐ Debris ☐ Grease

Silt Depth: **0.25** (in.) Deposits Extent: **Light**
